SIC01 - Secondary Injection Controller V1.0

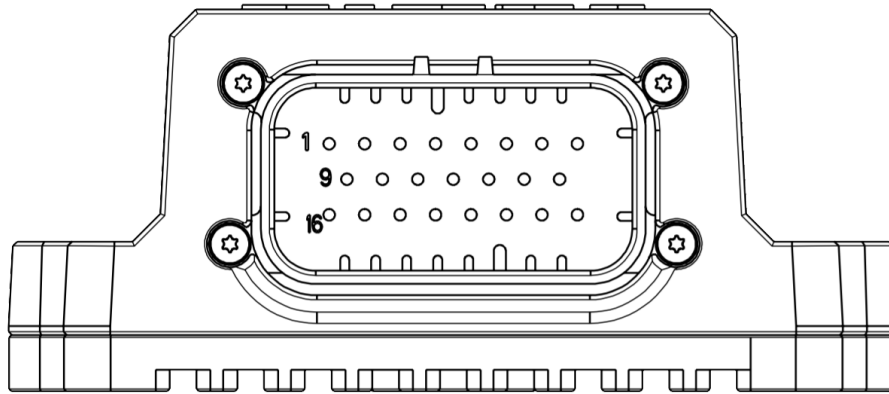
PIN		
NO.	NAME	DESCRIPTION
1	5V +	Input Signal ref and 5V from ECU
2	GND5	Signal GND from ECU
3	DI+	Direct Injection Signal (+)
4	DI-	Direct Injection Signal (-)
5	IDC	Secondary Injector Duty Cycle Analog Out
6	NC	No Connect
7	NC	No Connect
8	NC	No Connect
9	GND12	Chassis GND, Injector Power Ground
10	INJ -	Injector Pulsed Ground
11	INJ -	Injector Pulsed Ground
12	NC	No Connect

PIN		
NO.	NAME	DESCRIPTION
13	INJ +	Injector Switched 12V
14	INJ +	Injector Switched 12V
15	12V +	Battery 12V (+), Injector Power
16	INJ -	Injector Pulsed Ground
17	INJ -	Injector Pulsed Ground
18	INJ -	Injector Pulsed Ground
19	INJ -	Injector Pulsed Ground
20	INJ +	Injector Switched 12V
21	INJ +	Injector Switched 12V
22	INJ +	Injector Switched 12V
23	INJ +	Injector Switched 12V
